THE MAGAZINE OF THE AMERICAN SOCIETY OF CIVIL ENGINEERS

A MOVING MYSTERY

By DAVID K. LYNCH, PH.D., AND TRAVIS DEANE, P.E., G.E.

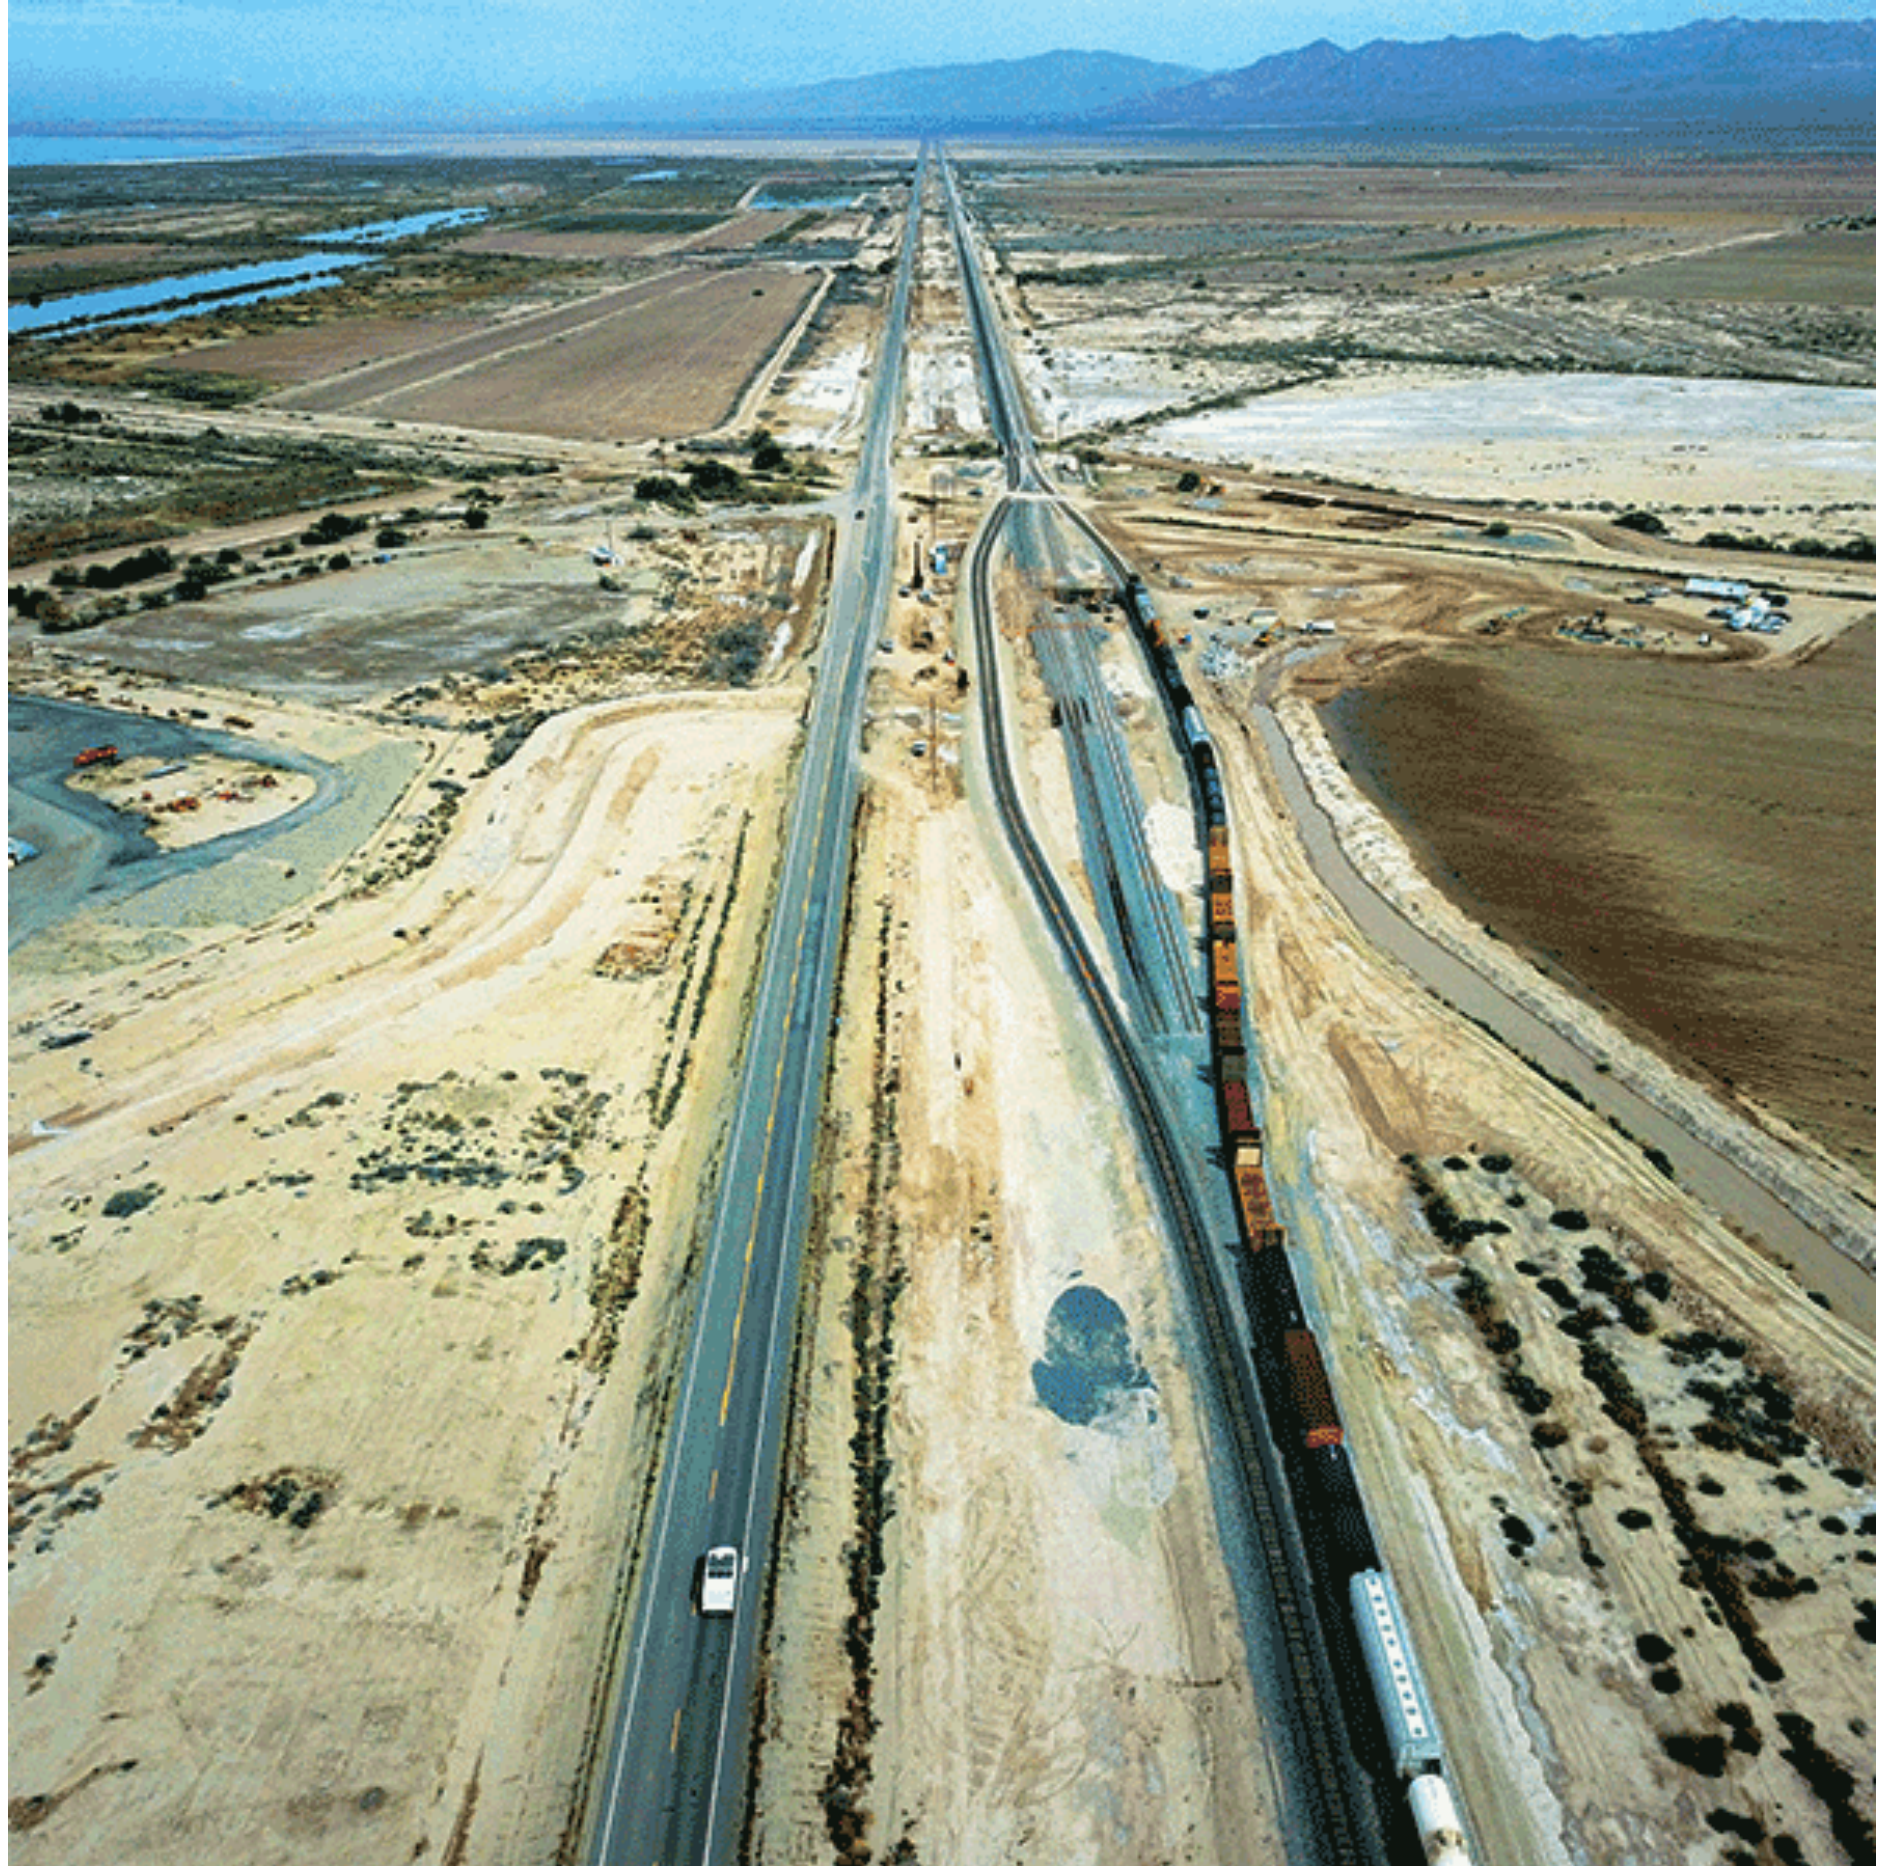
A moving mud spring developed in 2016 in Imperial County, California, that threatened railroad tracks and other local infrastructure. (David K. Lynch)

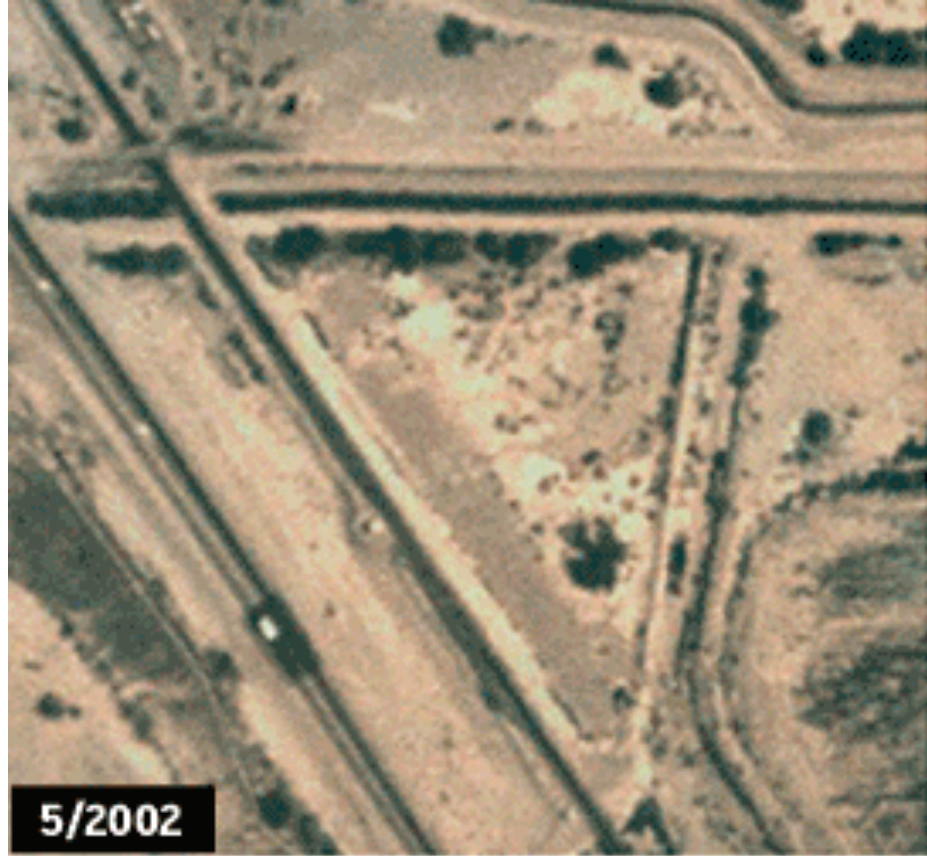
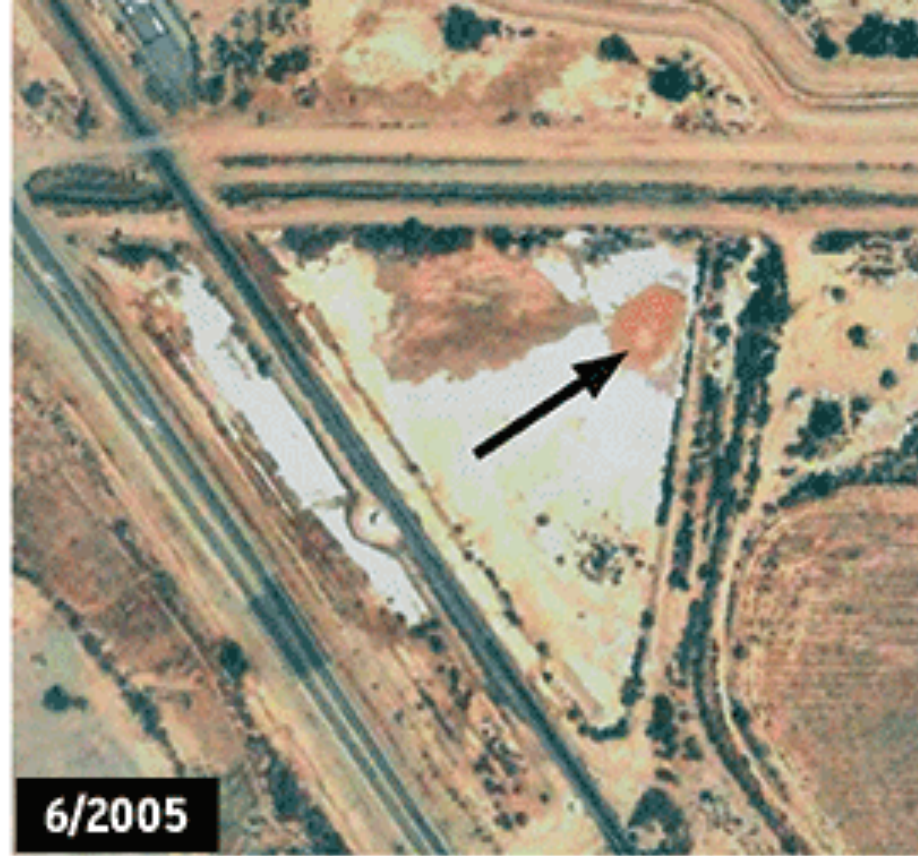
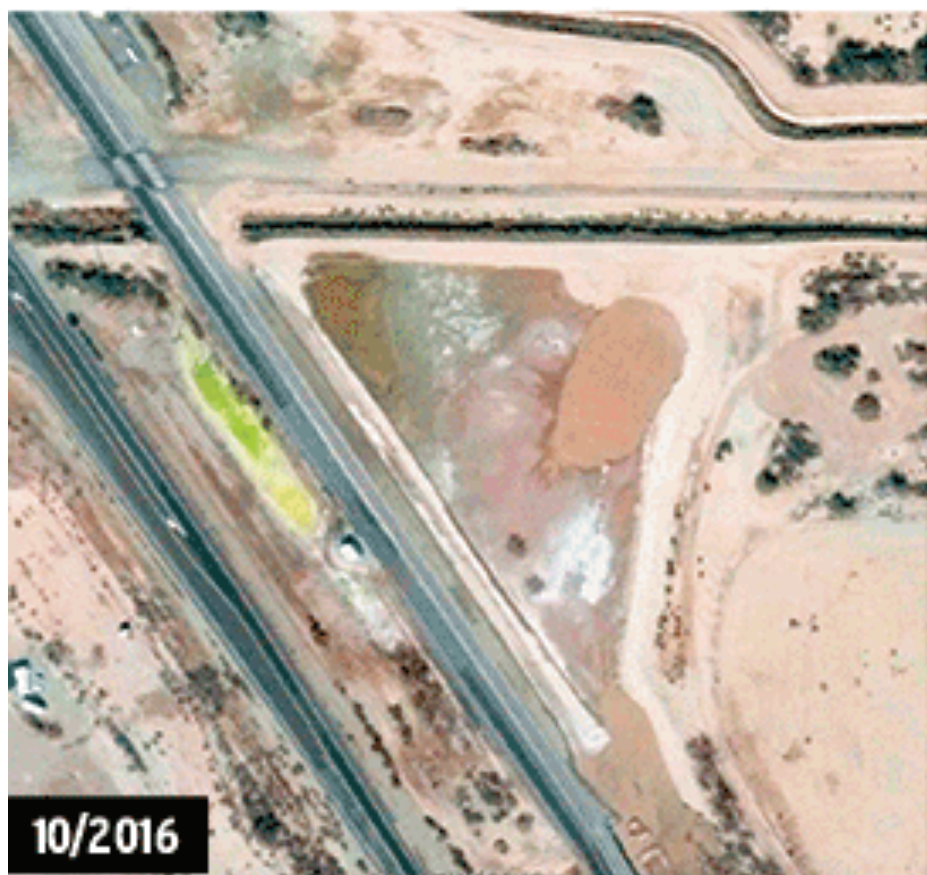
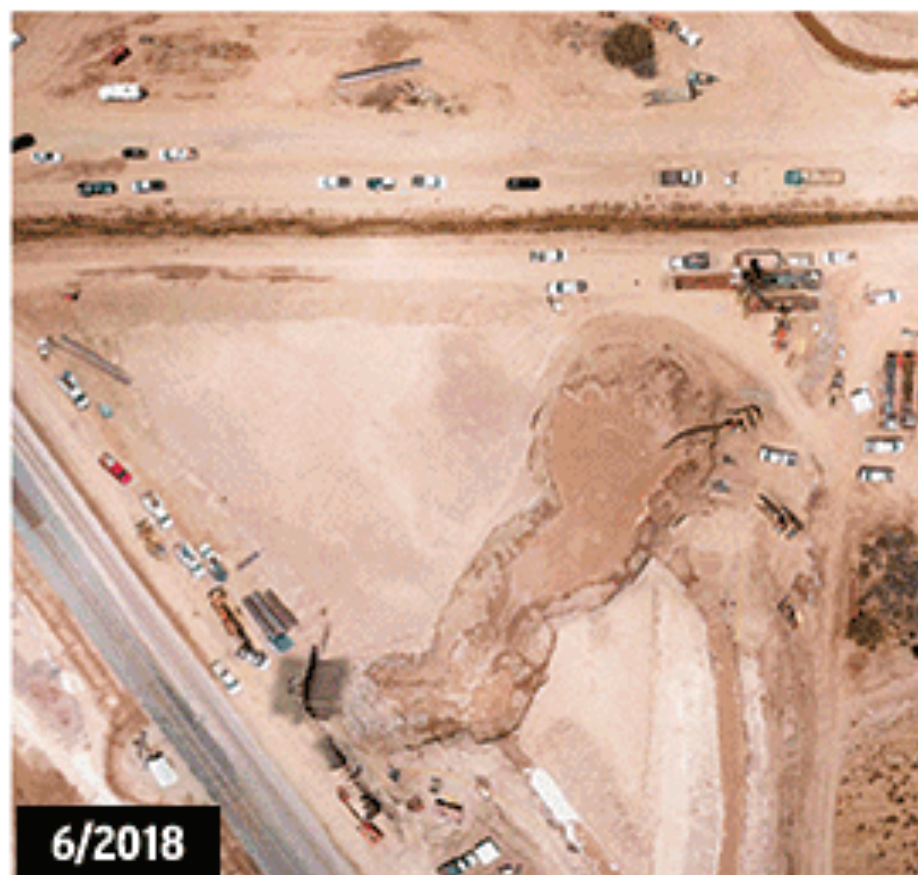
The time series from Google Earth shows the appearance of W9 and the first detection of the moving mud spring (in 2016) as a southwestern elongation in W9. (images adapted from Google Earth by David K. Lynch)

Surface water and moisture also appeared west of W9 on either side of the railroad tracks and adjacent to the highway in 2005. By 2017, much of the soil in the parking lot of the Wister unit of the Imperial Wildlife Area, which is located west of Route 111, also showed areas of surface moisture along west-southwest-trending lineaments. These moist areas were thought to be water that was related to W9, and their west-southwest orientation suggested cross faults through which water could rise to the surface (see the image labeled 7/31/2018).

However, this did not work because most of the rock sank into the mud and vanished below the surface (see the image labeled 7/31/2018).

more westerly (see the image labeled 8/26/2018).

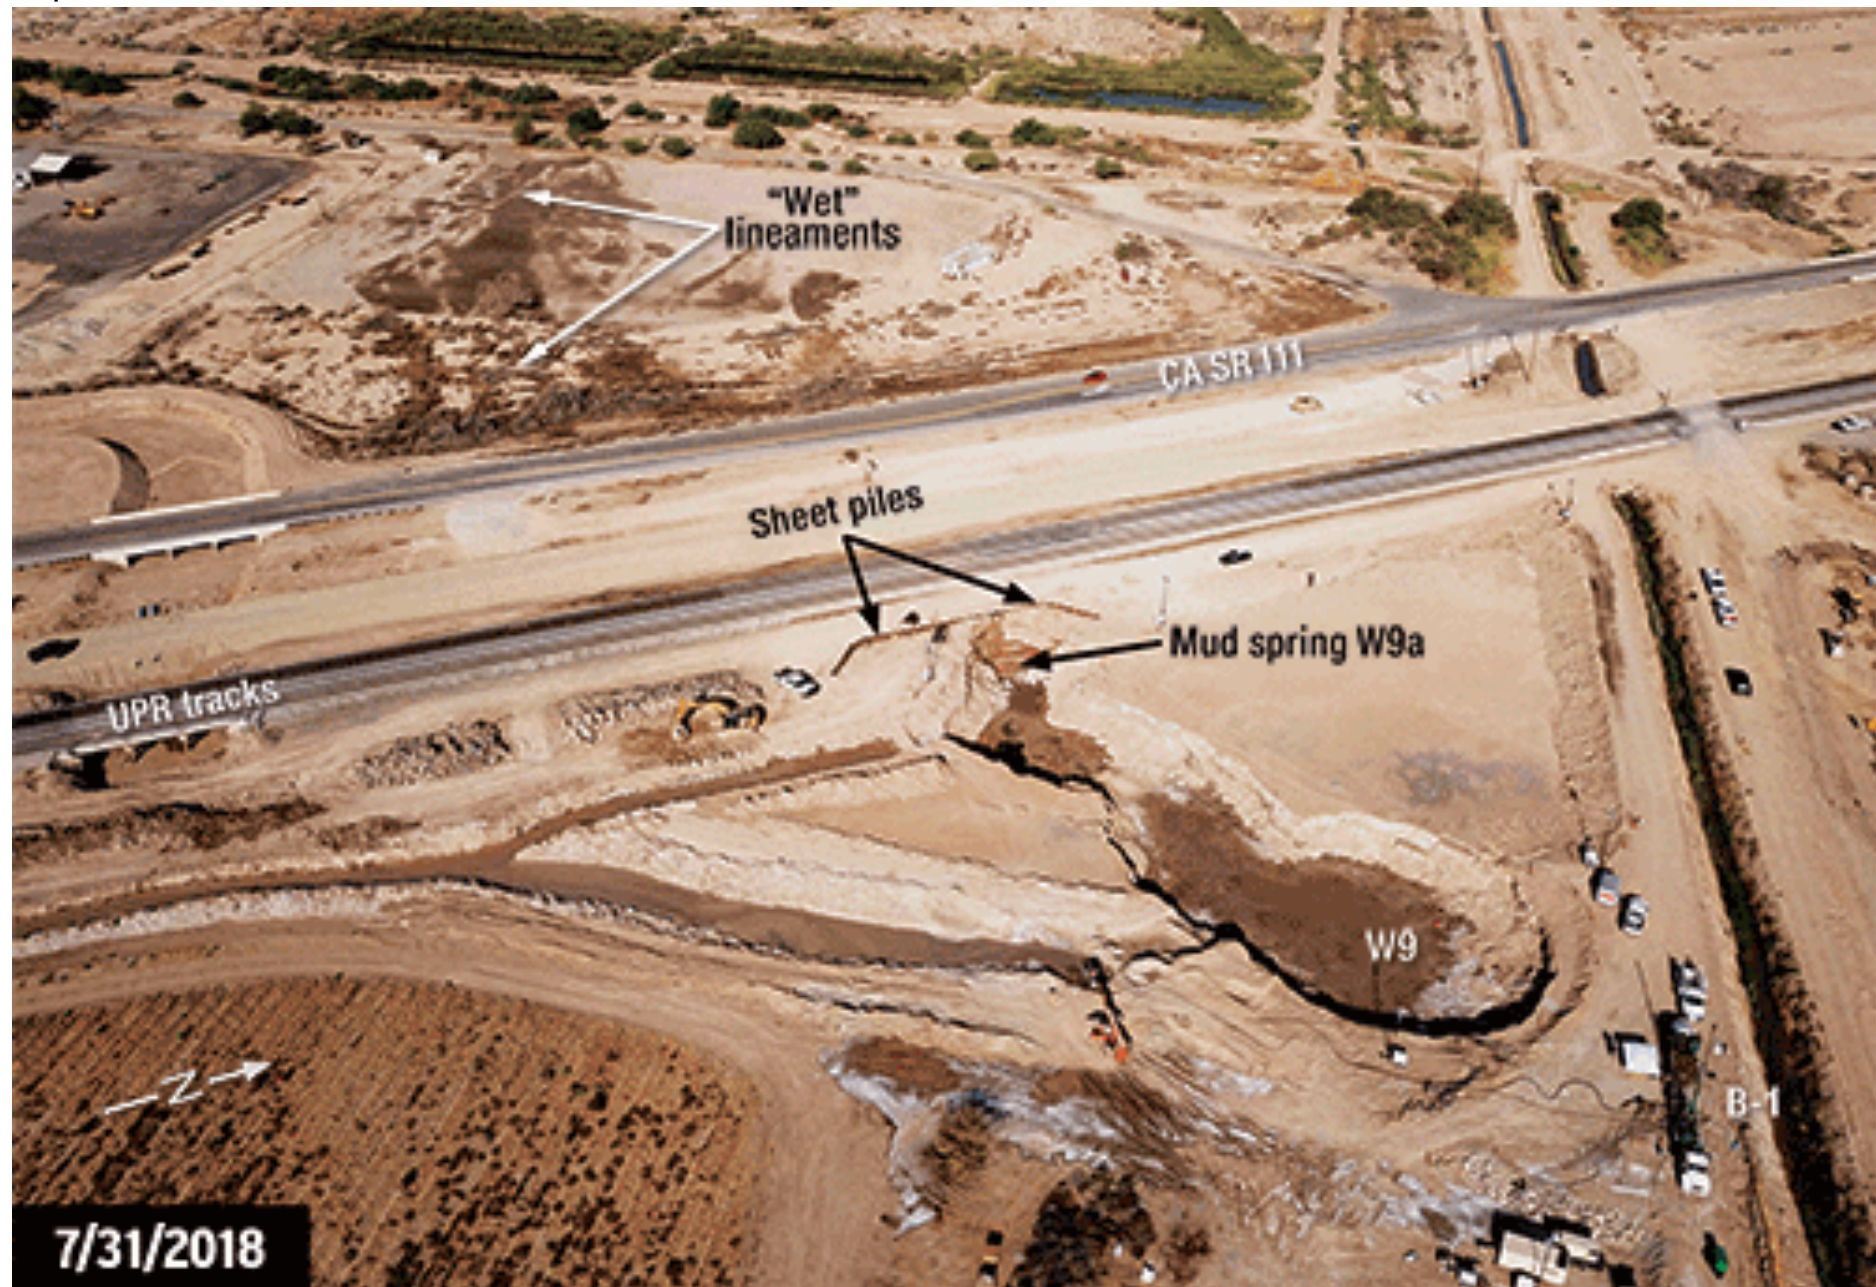
W9 and W9a split, with W9a carving out a large basin that was filled with muddy water. (David K. Lynch)

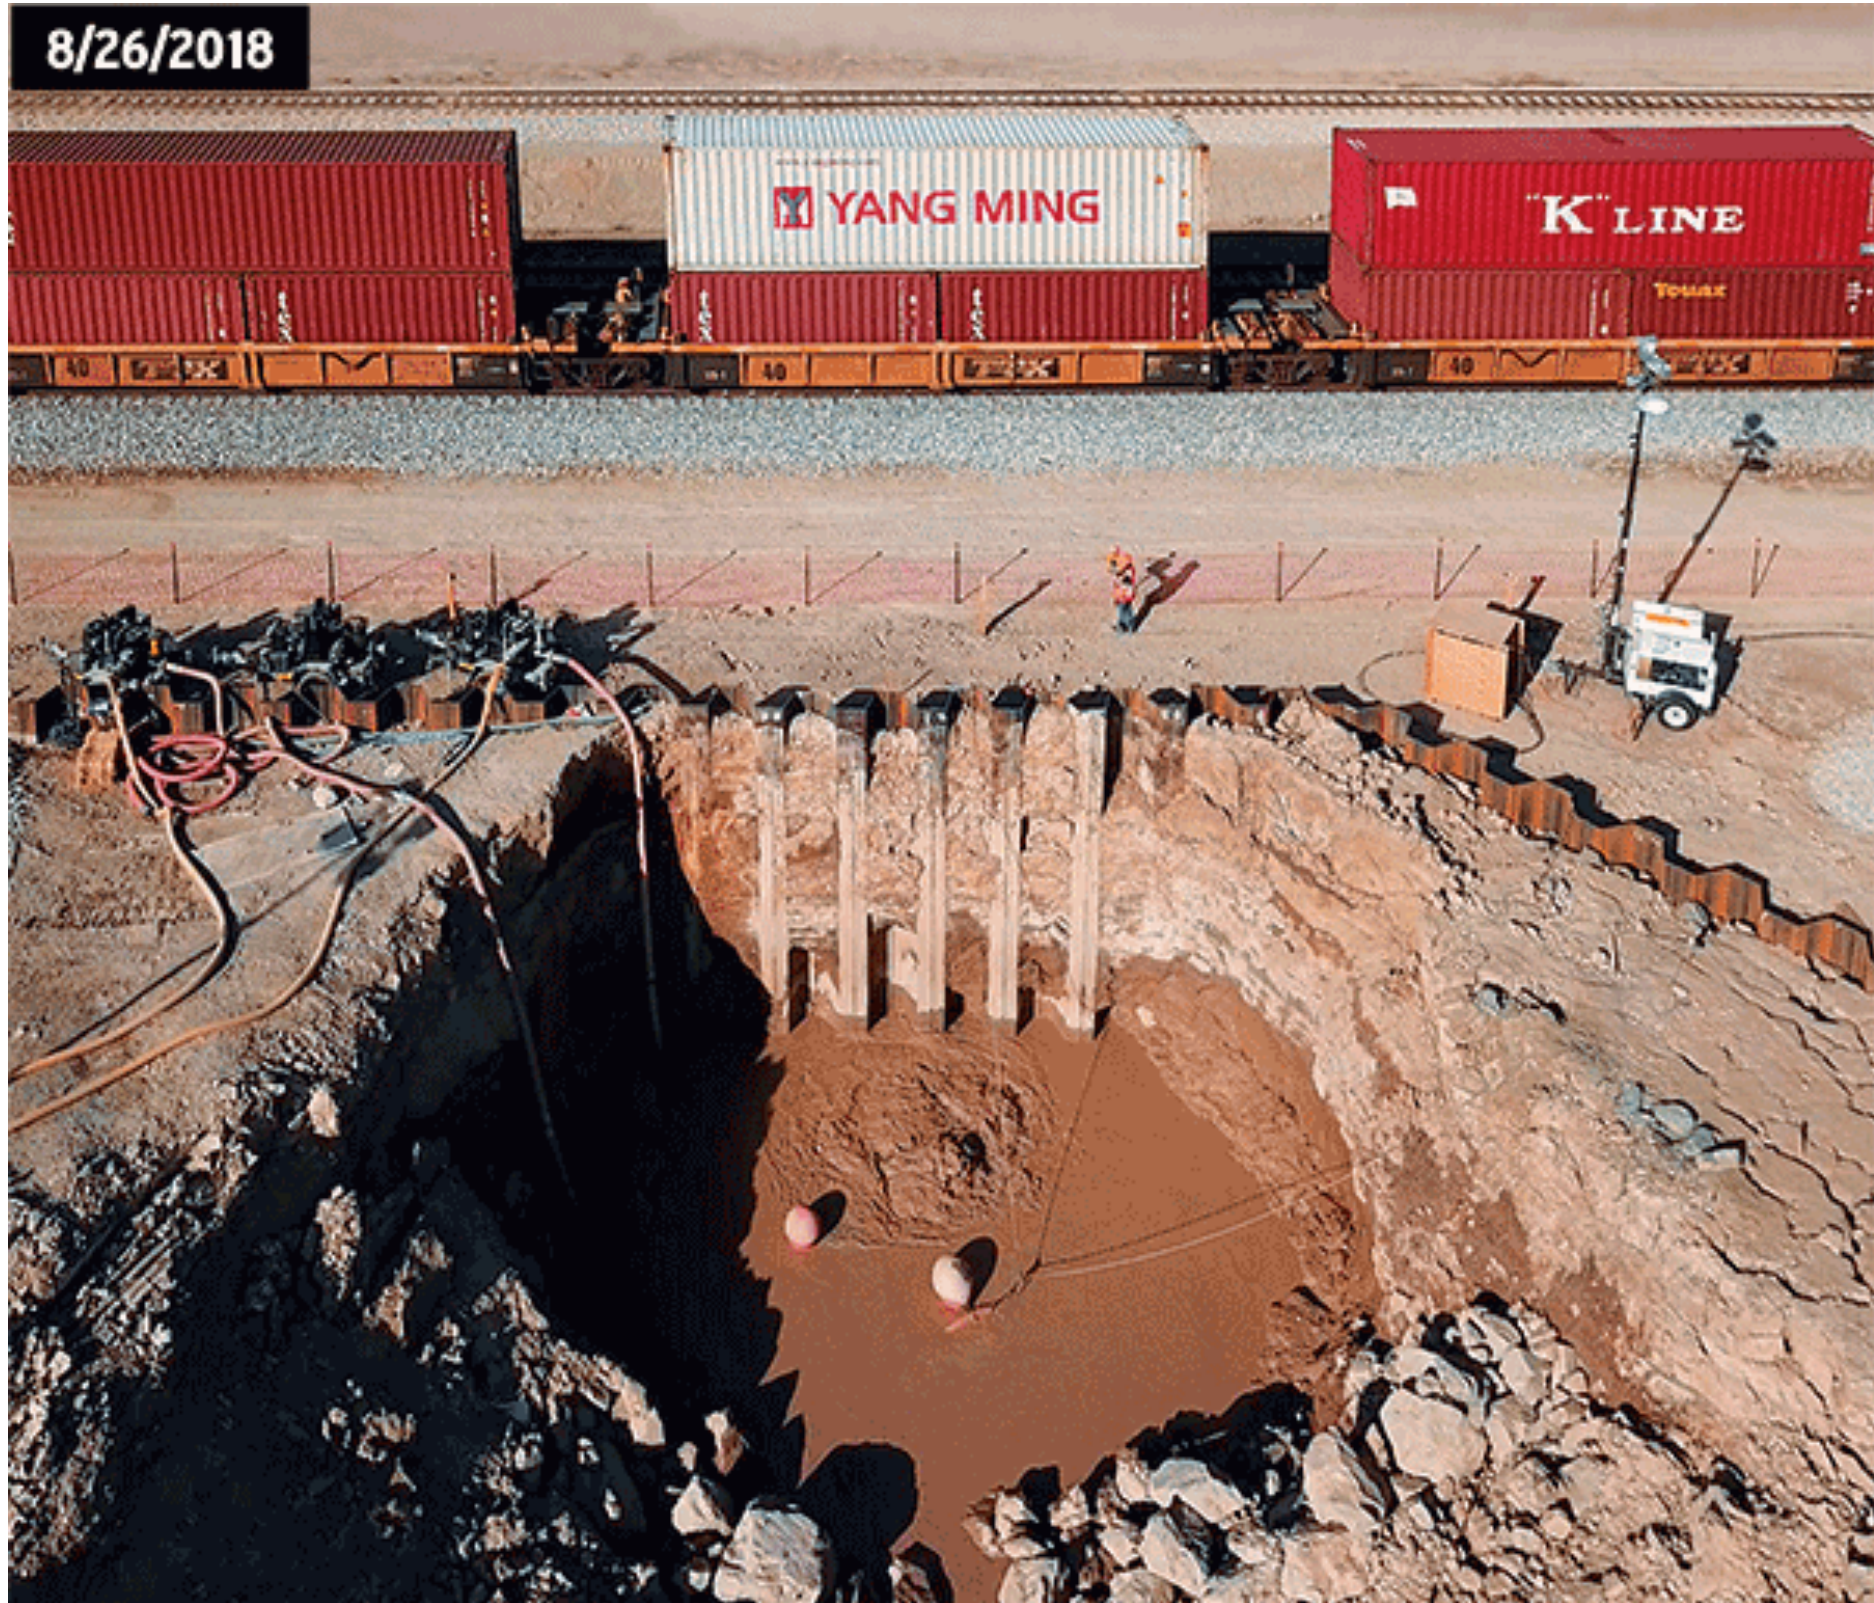
A 140 ft long sheet pile wall was constructed to slow W9a's southwesterly movement. (David K. Lynch)

In May and June, a 140 ft long sheet pile wall was constructed and inserted to a refusal depth of 75 ft to stop or slow W9a's southwesterly movement and to maintain the integrity of the sediment between the sheet piles and the railroad tracks. Not long after the wall was installed, the mud spring changed direction and began moving

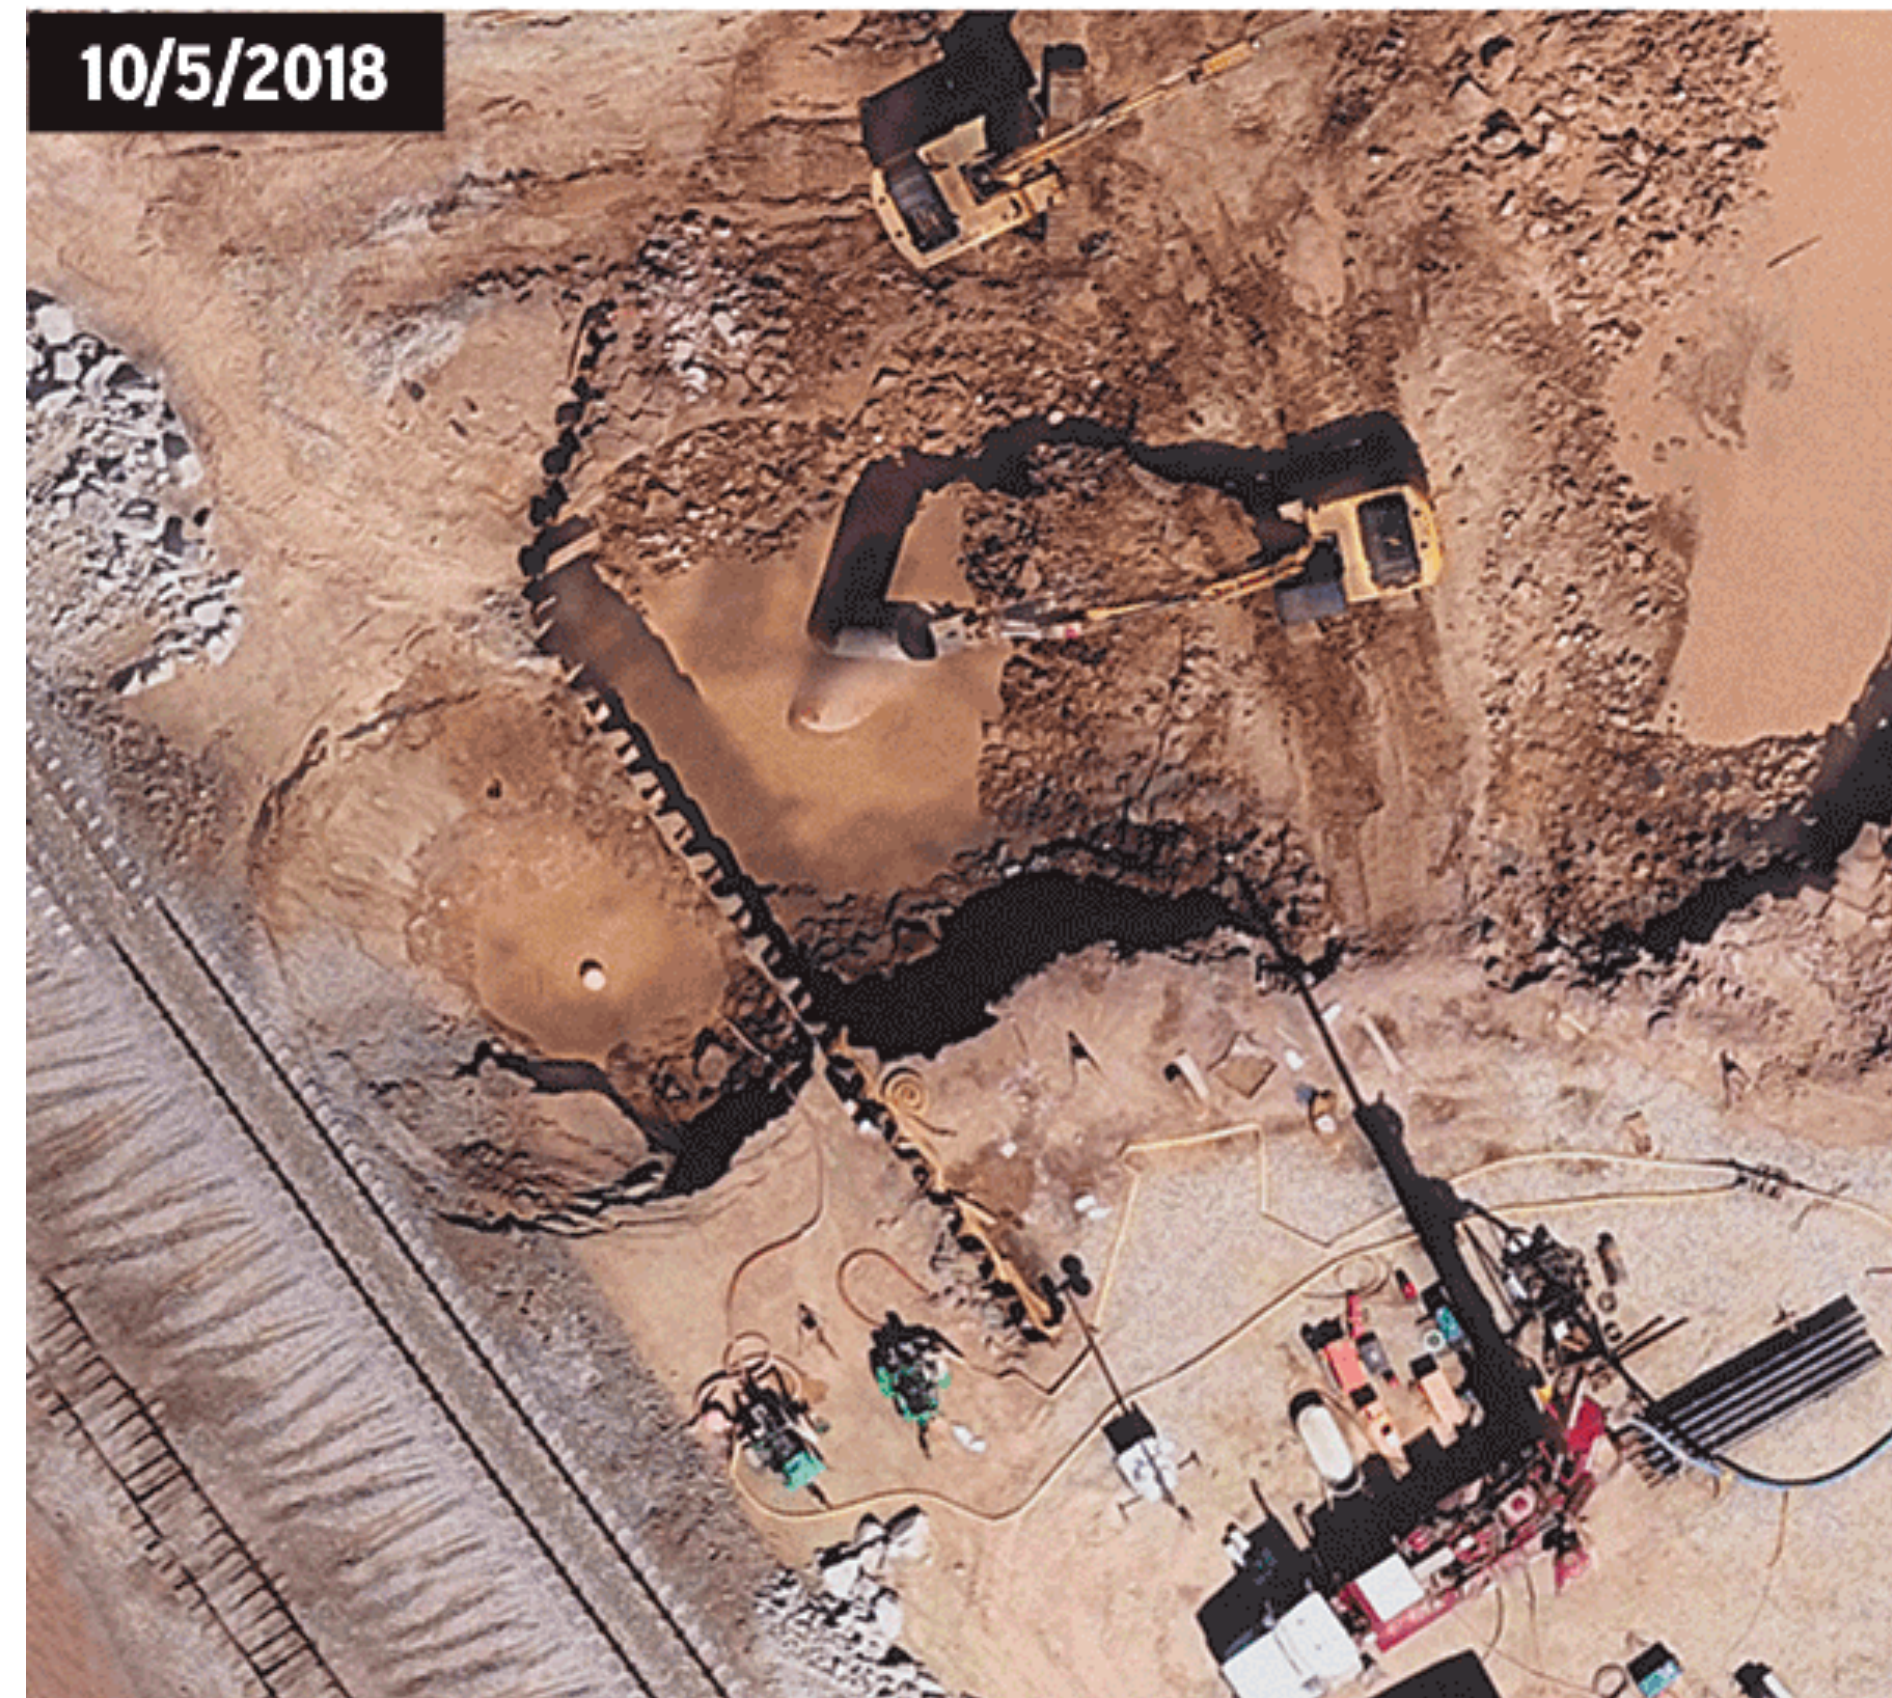
An approximately 60 ft wide and 25 ft deep sinkhole suddenly emerged west of the sheet piles, extending to the ballast shoulder on Main 1 track. (David K. Lynch)

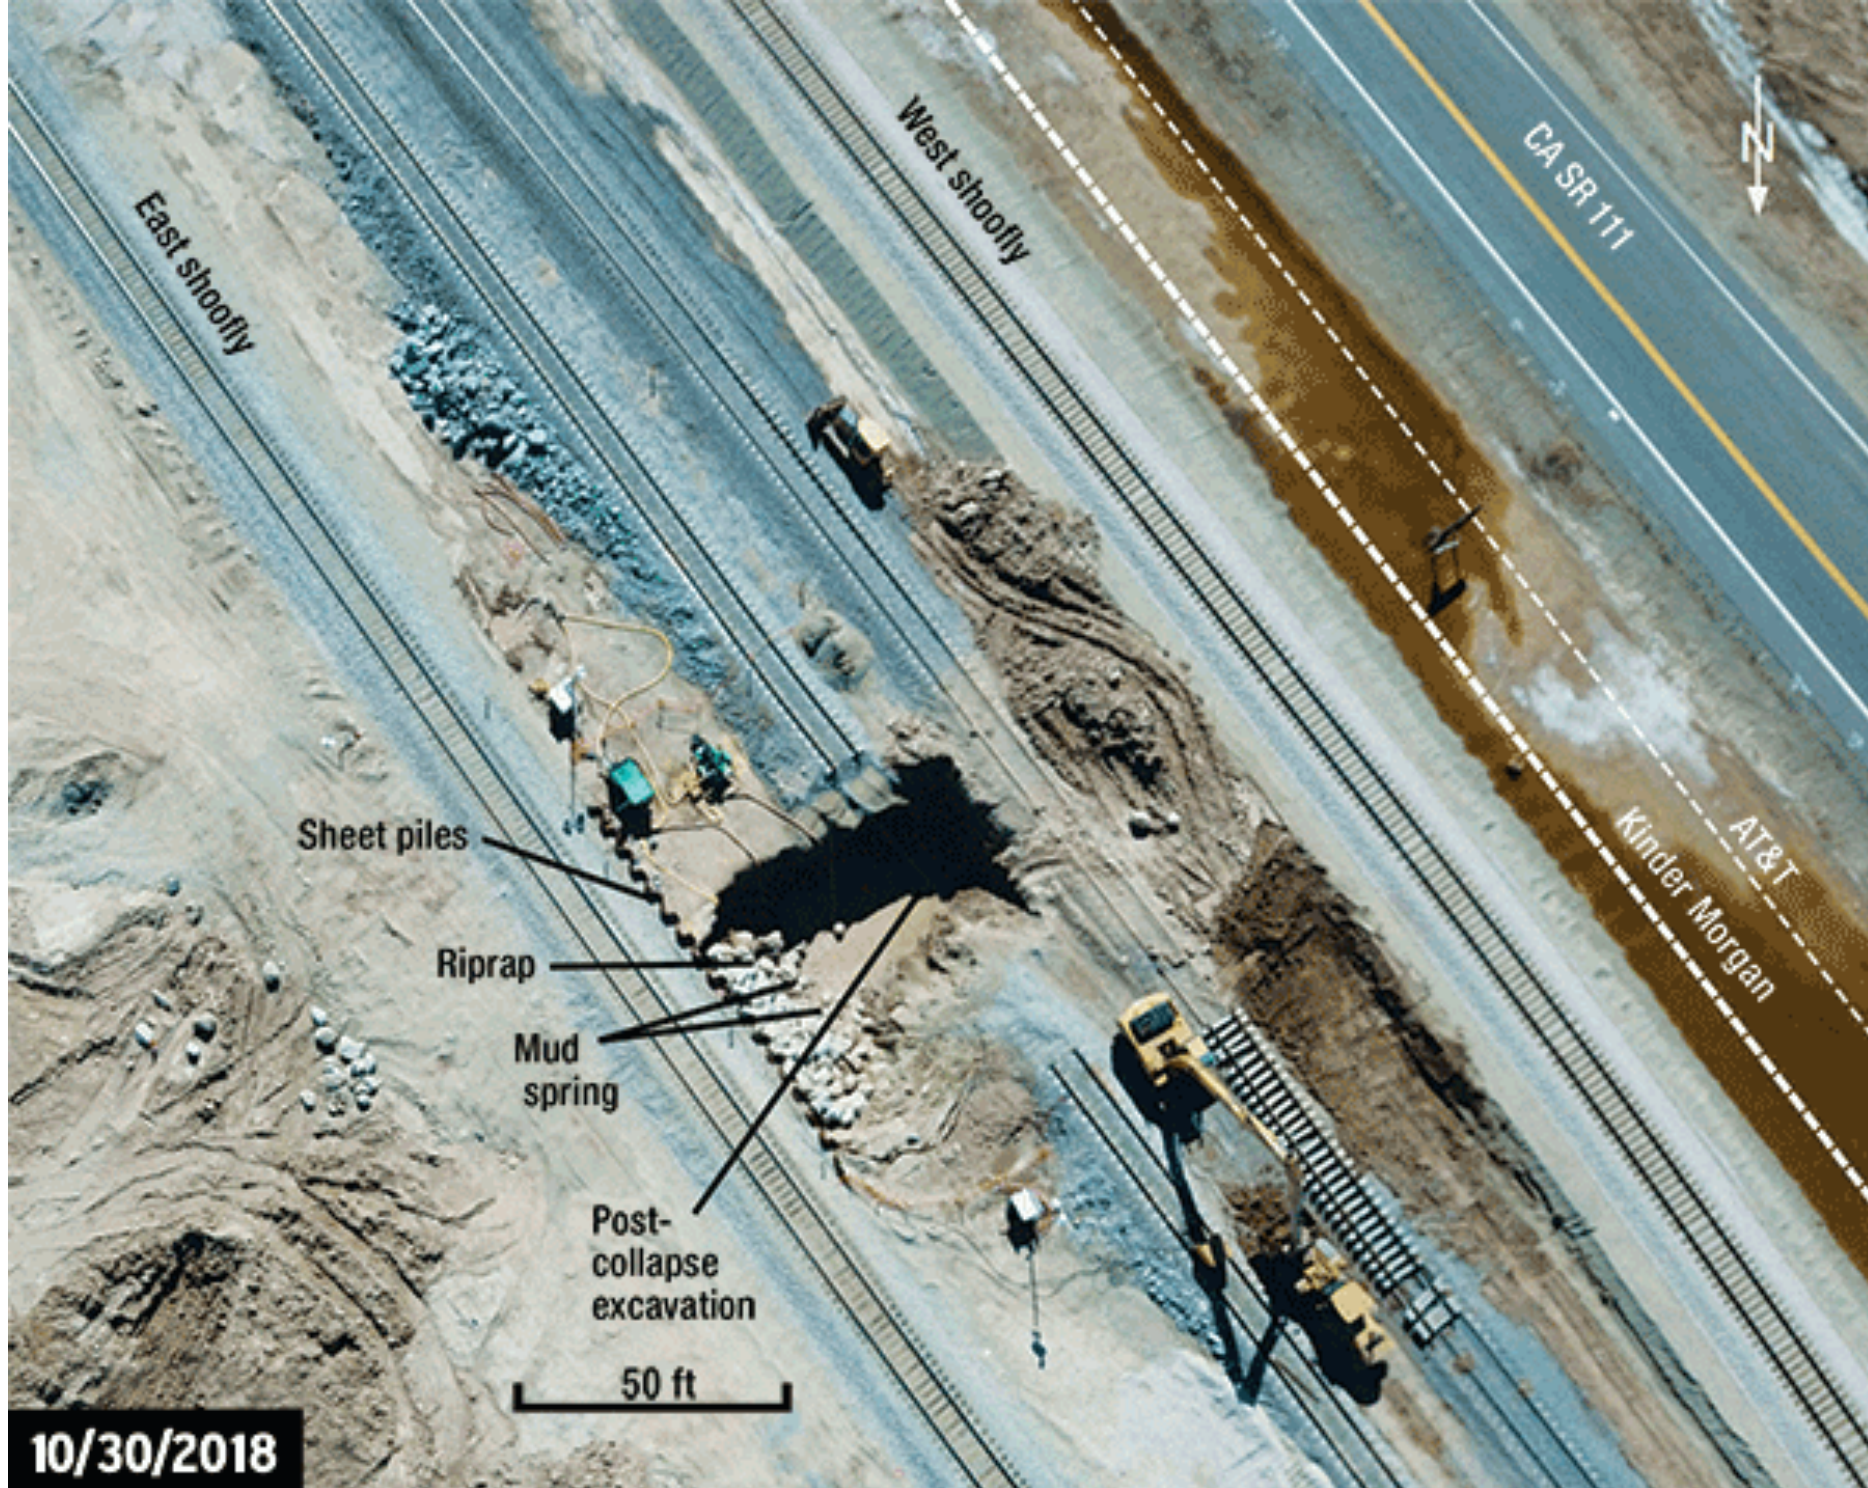
Work crews partially filled the sinkhole with riprap west of the sheet piles to ensure that the sediment supporting the east shoofly did not move. A west shoofly was built so that there were two railroad tracks in operation again. (David K. Lynch)

Riprap was used to buttress the sheet piles on the west side, and the mud spring basin on the east side was backfilled with sediment. Soon, individual piles began to sink into the mud and tilt westward into the sinkhole; therefore, more riprap was placed into the sinkhole against the sheet piles. Later that month, the sinkhole was excavated to the southwest to monitor the spring's movement and help predict its path (left).
